The wear guard (S56459) in between the IP Boot and the C2 shank may wear over time and cause damage to the IP boot if not checked regularly.

Use the following procedure to replace wear guards as needed.

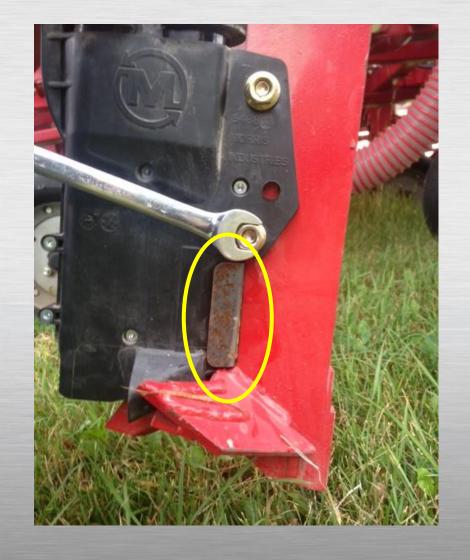
- The wear plate may need to be replaced after a number of acres, this is highlighted in the picture on the right.
- Use 9/16" wrenches to remove the 3/8" bolts.

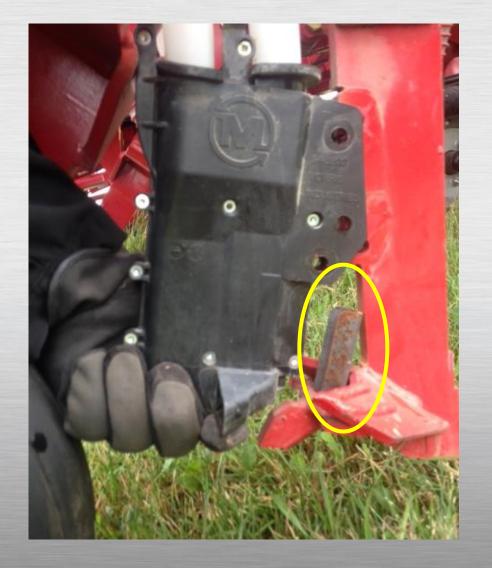
Once the bolts have been removed, pull the boot back and remove the wear guard.

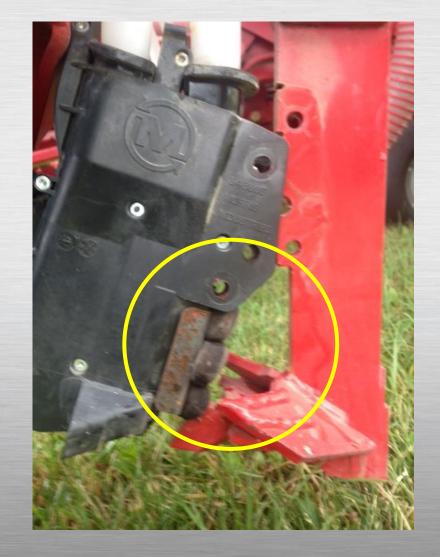
• Insert the new wear guard, ensuring the locating dowel in the boot fits securely into the locating notch of the opener.

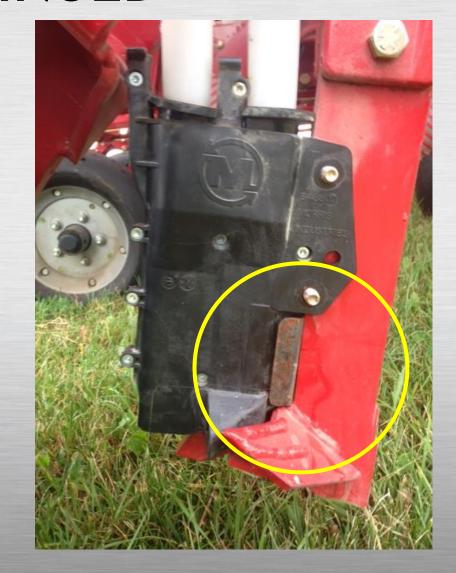
STEP 3 CONTINUED

- Insert the new wear guard, ensuring the locating dowel in the boot fits securely into the locating notch of the opener.
- It should fit similarly to the picture shown here:

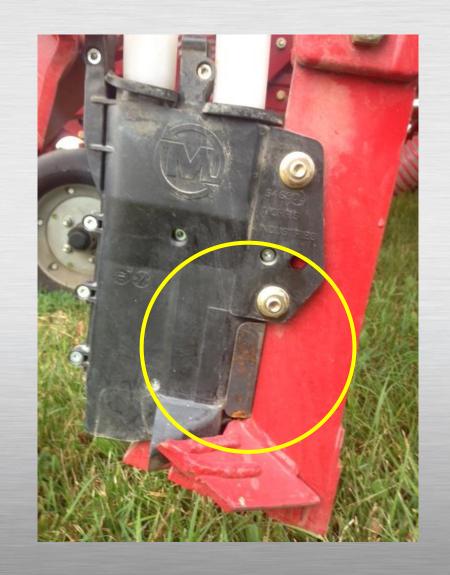
- Once in place, insert the bolts and snug up the lock nuts.
- You may also consider using blue thread lock.
